North Point Home Inspections

Confidential - Property Inspection Report - Confidential

Woods Lane, Lewiston, MI
Inspection prepared for:
Date of Inspection: 11/8/2014 Time: 9:00
Age of Home: 1993 Size: 2400 SF
Weather: 35 Rain

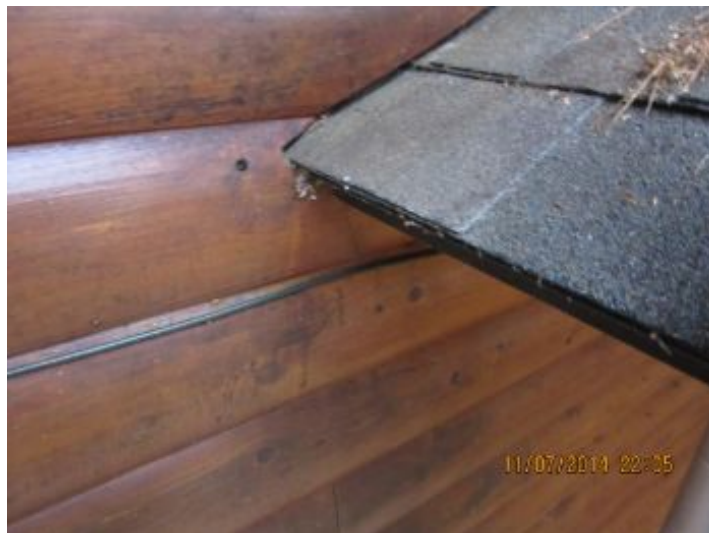
Improvement: Add kick out flashing at eave/vertical walls

Observations: Visible areas appeared functional, at time of inspection • Chimney flashing needs to be reviewed for proper height at chimney. Have a tradesman repair as necessary. • Recommend installing a "Kickout diverter flashing" where roof eaves connect with vertical walls.

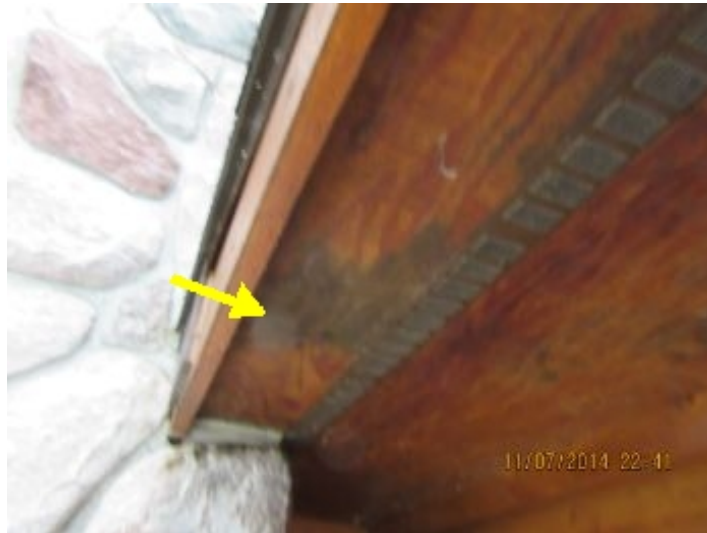
- Warping at soffit near chimney. Have this area reviewed for necessary repairs.

Warped soffit area at chimney

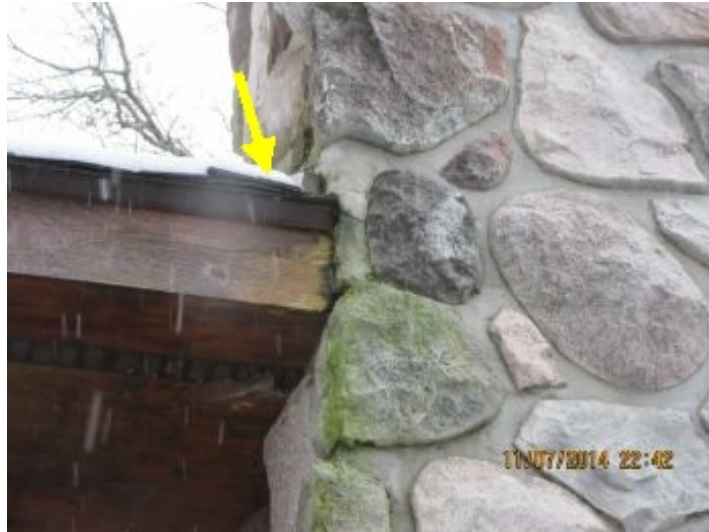
- Masonry chimney appeared functional with no deficiencies noted -- proper chimney cap installed. Sealant at the base is aged and needs to be redone.

Review flashing at chimney

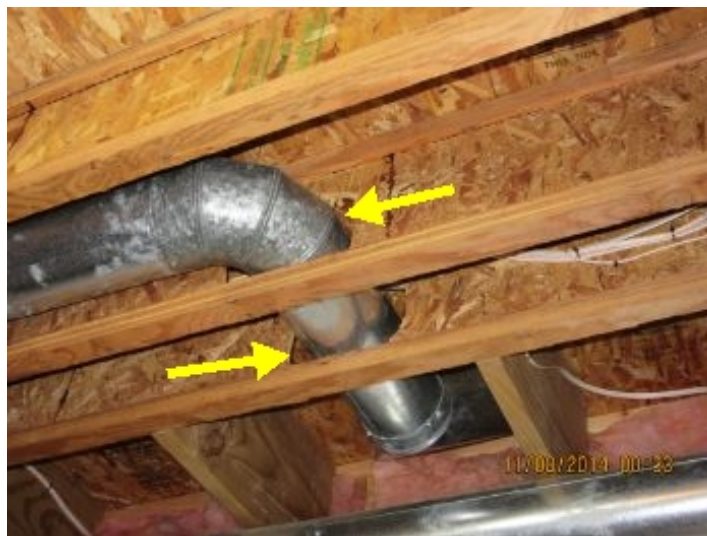
- Holes cut for duct work are improper. I recommend review by a qualified professional for repair or replacement as necessary.

Improper holes in floor joists

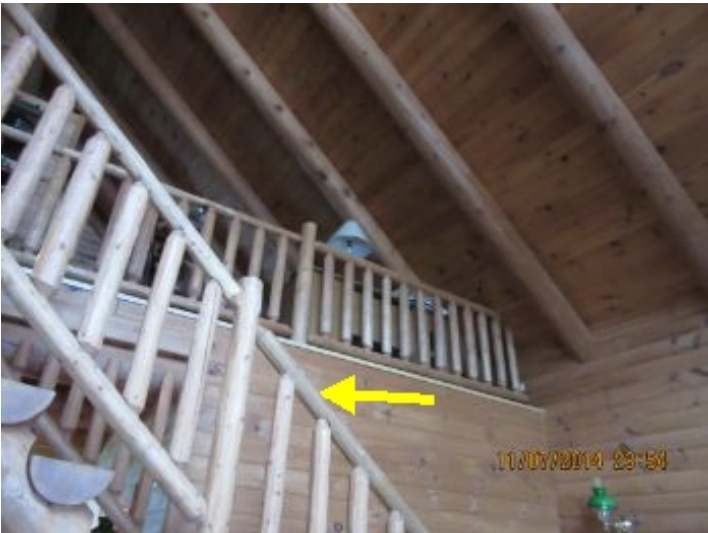
- Loose railing to upper level. Repair as needed.
- Missing railing to basement. Have railing installed for your safety.

Unstable rail to upper level

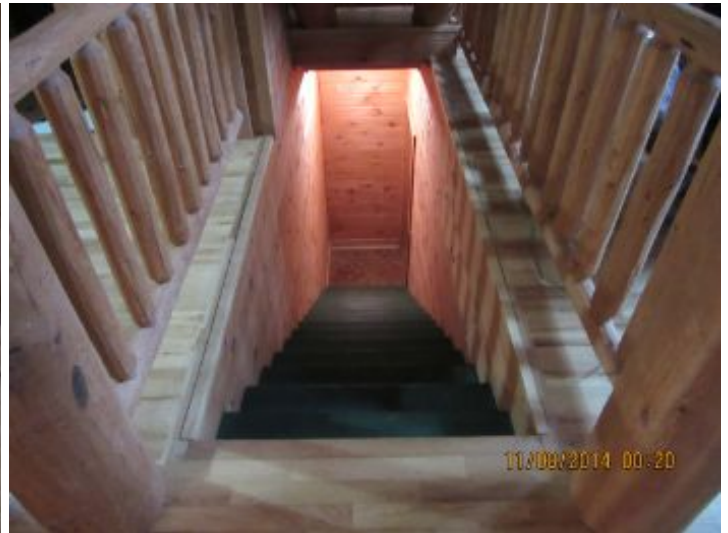
Add rail to basement

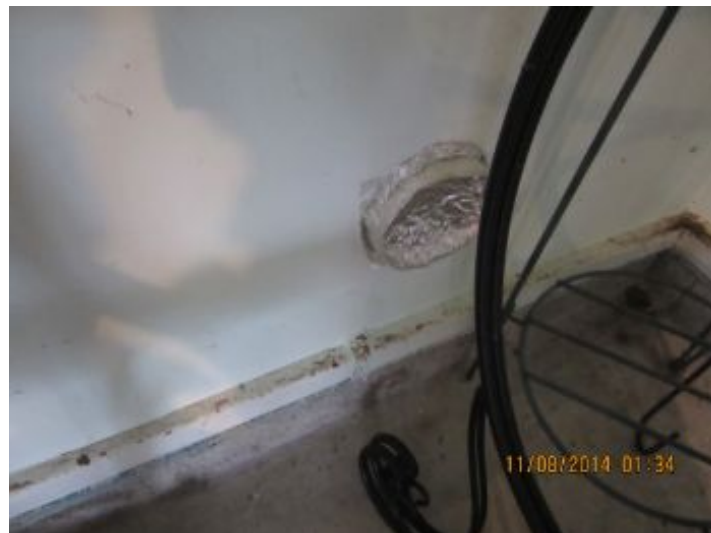
- PVC pipe breeches firewall. I recommend this be removed or covered with a metal cap.

Remove or cover PCV pipe

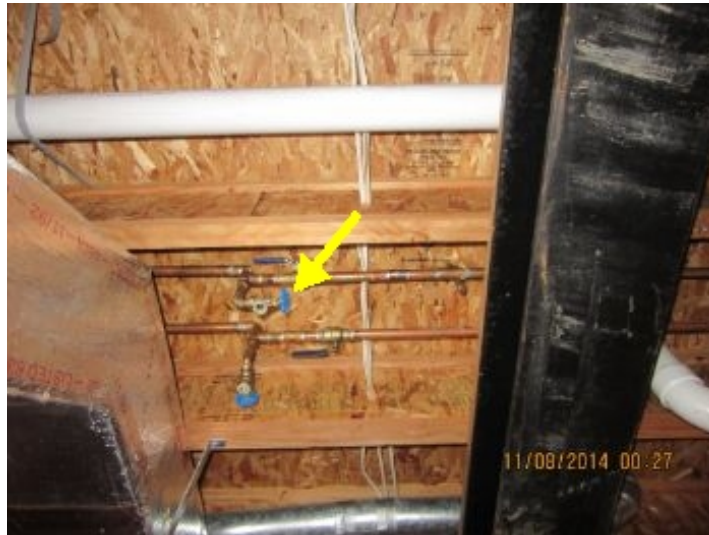
- Leaking water supply pipes at basement ceiling need to be repaired.

Leaking supply plumbing

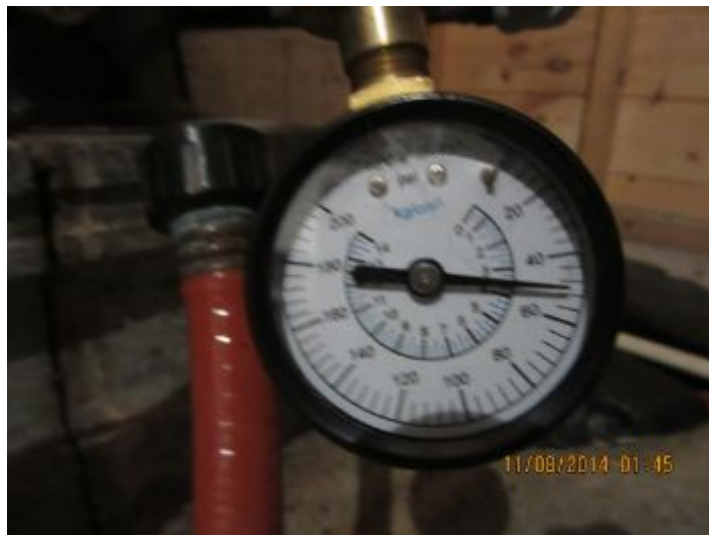
Pressure: 50 PSI
 Observations:
 • The water flow was overall functional. This was determined by running water in the bath sink and shower while toilet is flushed.

Static water pressure
